Manhole Inspection Summary

Manhole # S13AA_075MH

Inspection ☐ Is Incomplete Rating: **3) Fair**

Location Address: **2823 MOSHER ST**

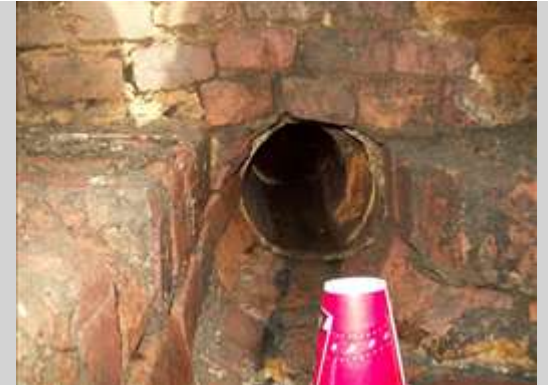
12 O'Clock Outflow

8 in. Circular Gravity Sewer
Pipe Out @ 12 O'Clock

Pipe Material: **Clay** ☐ Pipe Lined

Invert Depth: **3.70** (ft.) Flow Characteristics: **None**

Deposits: ☒ None ☐ Mud ☐ Sludge ☐ Debris ☐ Grease

Infiltration: **None** Pipe Seal Cond: **Sound**

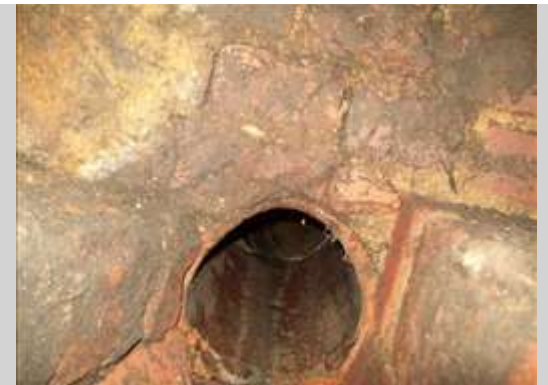
3 O'Clock Inflow

6 in. Circular Gravity Sewer
Pipe In @ 3 O'Clock

Pipe Material: **Clay** ☐ Pipe Lined

Invert Depth: **3.64** (ft.) Flow Characteristics: **None**

Deposits: ☒ None ☐ Mud ☐ Sludge ☐ Debris ☐ Grease

Infiltration: **None** Pipe Seal Cond: **Sound**

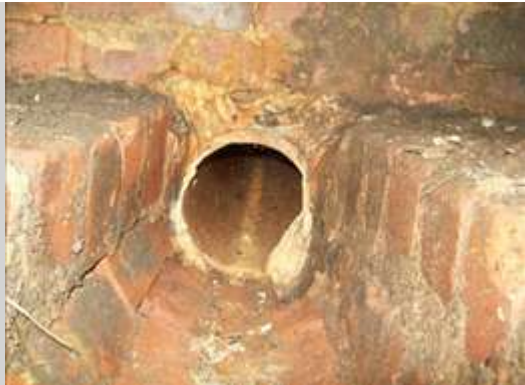
6 O'Clock Inflow

8 in. Circular Gravity Sewer
Pipe In @ 6 O'Clock

Pipe Material: **Clay** ☐ Pipe Lined

Invert Depth: **3.68** (ft.) Flow Characteristics: **None**

Deposits: ☒ None ☐ Mud ☐ Sludge ☐ Debris ☐ Grease

Infiltration: **None**

Pipe Seal Cond: **Sound**
